## HELICOPTER ROTOR DOWNWASH EFFECTS

SPECIAL REPORT ED&T 1818

HELICOPTER ROTOR DOWNWASH EFFECTS

U.S.D.A. Forest Service Equipment Development Center  
San Dimas, California

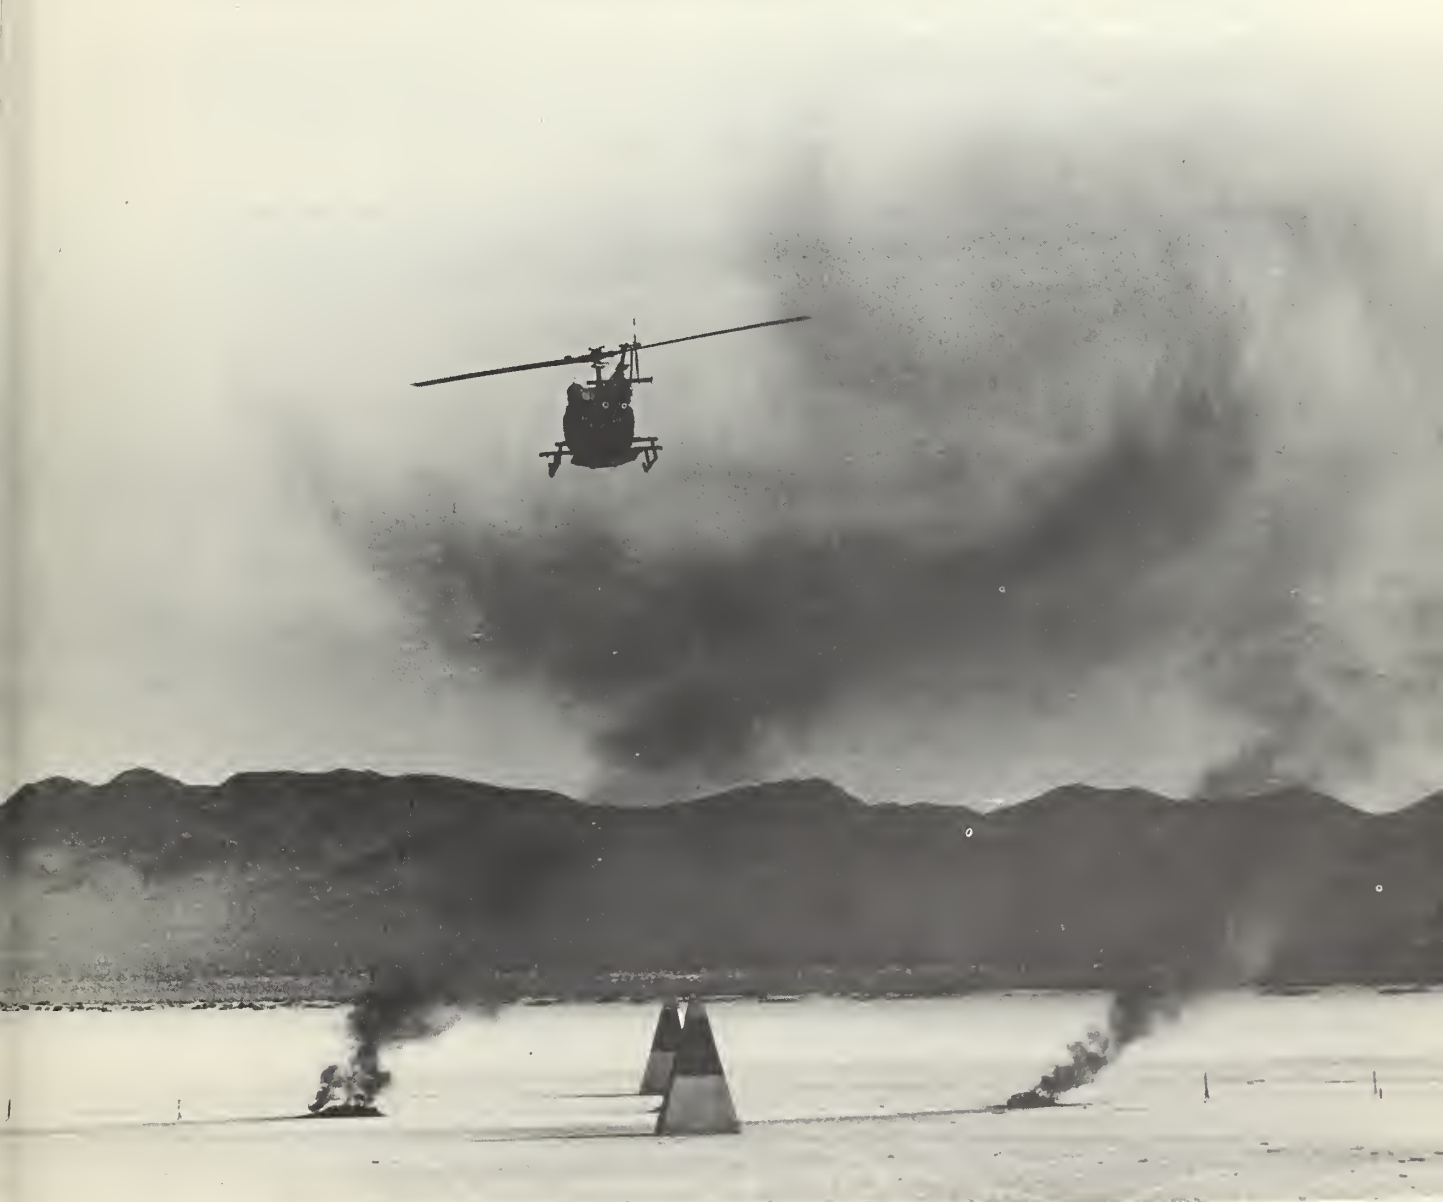
Figure 7. Typical Rotor Wake Configuration

1. Rotor wake and downwash descends at a measurable rate until it reaches the ground or is dissipated. Its downward force decreases with increased airspeed but can create an effect on the ground up to speeds of 35 knots at low altitudes.
2. Wind motion will influence effects from rotor wake and downwash by carrying it laterally and dissipating its strength.
3. Hovering downwash is primarily a vertical column one-half rotor-diameter across and is potentially dangerous up to 300 feet when directed from the 204B. For the 47 series, 150 feet indicates strong ground wash effects.
4. Rotor wake at forward speeds is shed from the rotor disc as a sheet and rolls up at the edges as two counter-rotating vortices, which descend at a measurable rate.
